Technical Report No: R240089

Aperture Weathering System

A reaction to fire test in accordance with;  
DD CEN/TS 1187:2012

Clause 7: Test 4 – Method with Two Stages Incorporating Burning Brands, Wind and Supplementary Radiant Heat

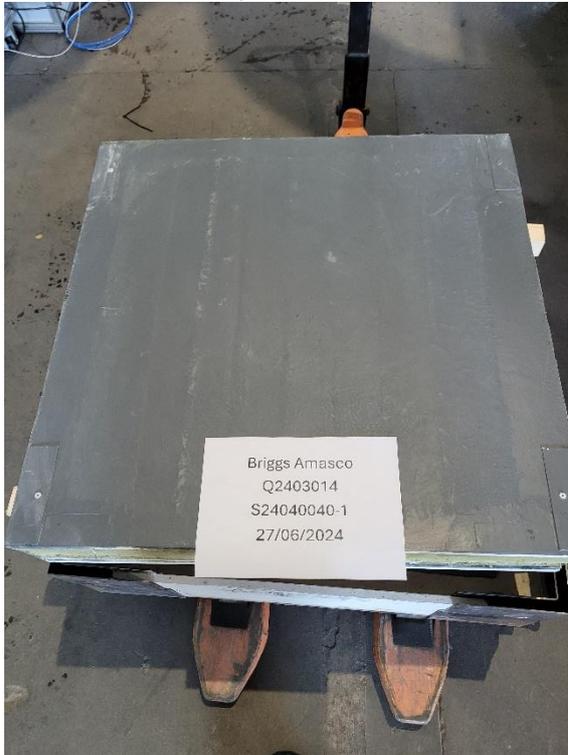
### 9.1 Stage 1 S24040040 -1

Pretest picture of specimen.

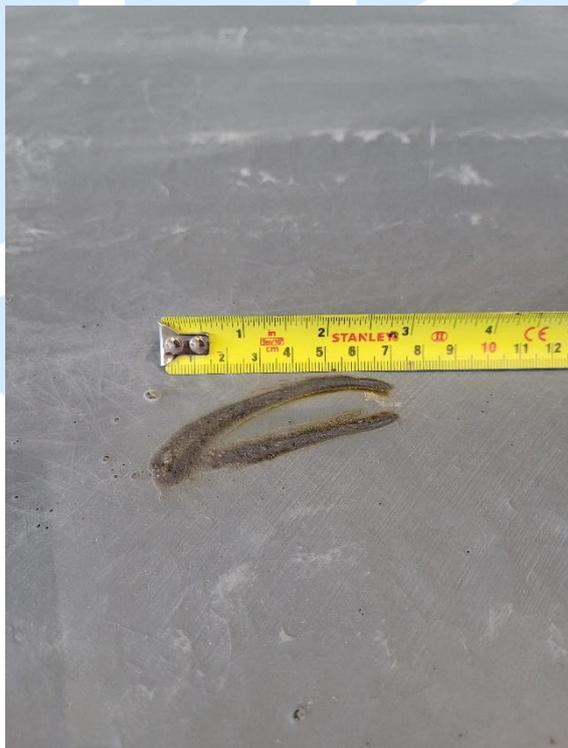
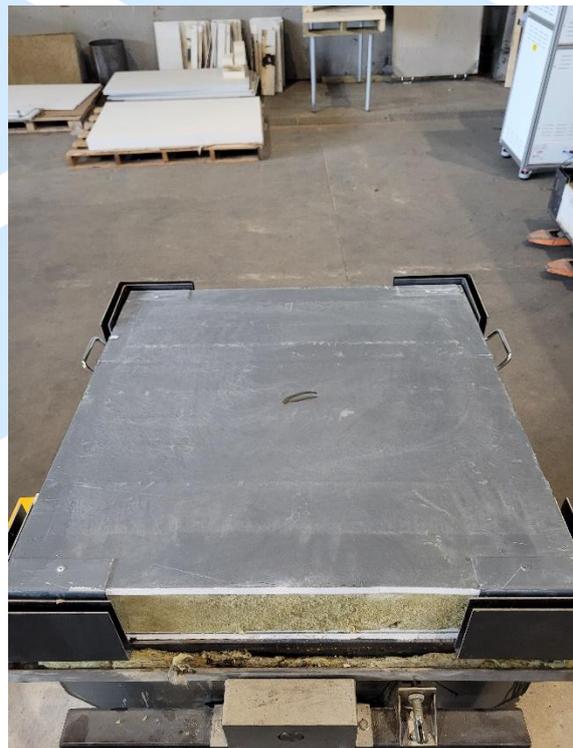
### 9.2 Stage 1 S24040040-1

Post test pictures of specimen.

Time (min:sec)	Observations on Sample No: S24040040 -1
00:00	Test start (burning brand applied)
01:00	Test end (burning brand removed)
Post test	Surface scorch mark measuring 70mm in length. The specimen surface did not remain ignited after the burning brand was removed.

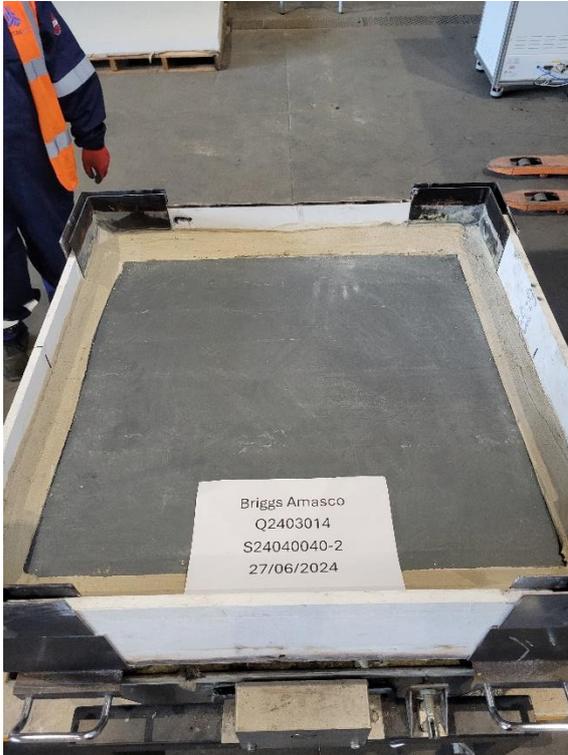
**9.3 Stage 2 S24040040 -2**

Pretest picture of specimen.

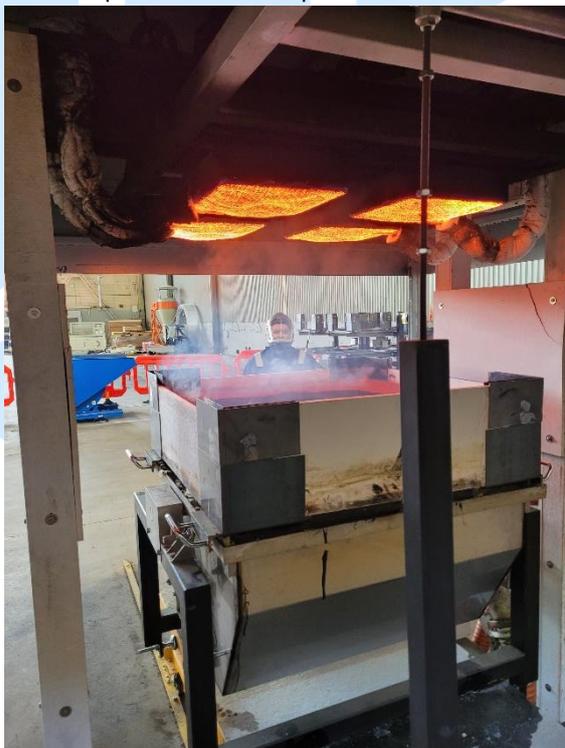
**9.4 Stage 2 S24040040-2**

Smoke produced from specimen.

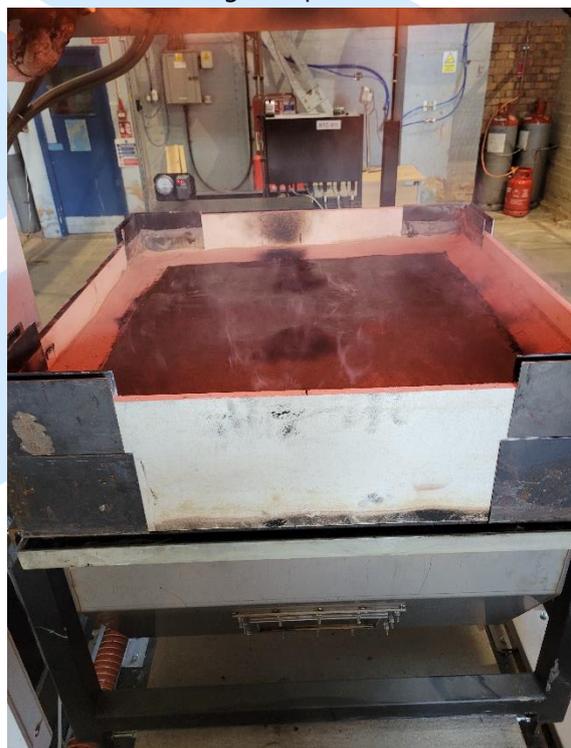
Post flames damage to specimen.

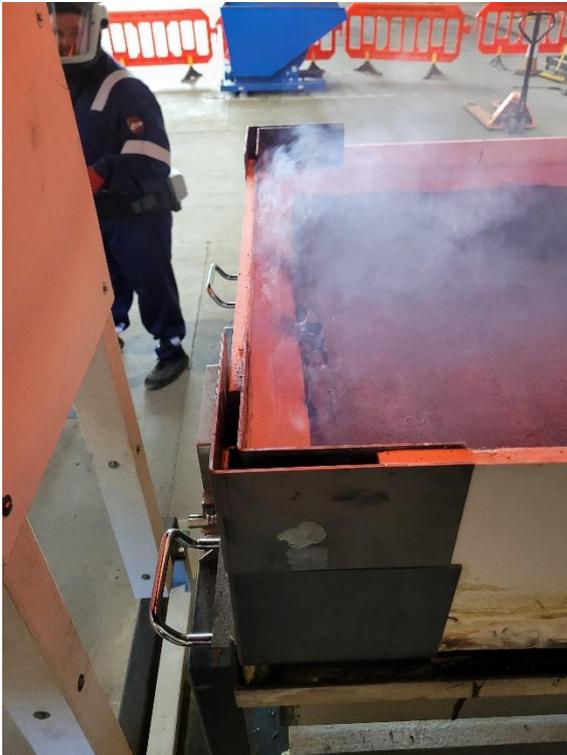
**9.5 Stage 2 S24040040-2**

Peeling of specimen surface.

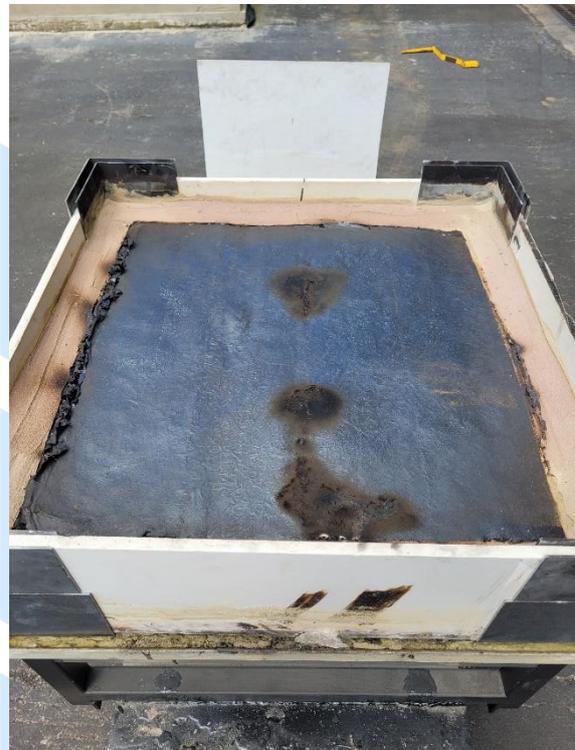
Post test surface damage.

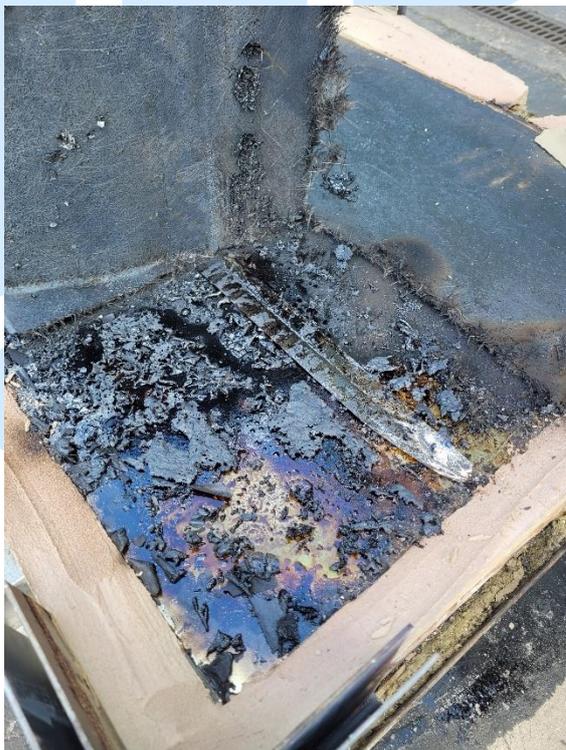
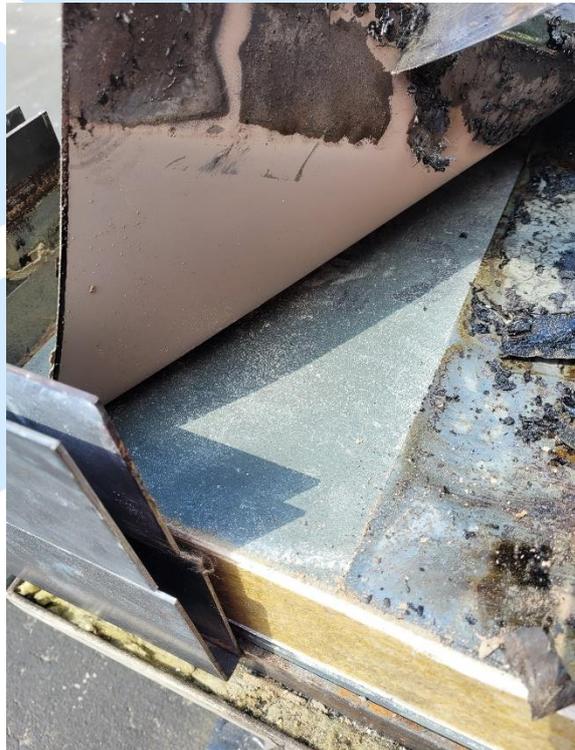
**9.6 Stage 2 S24040040-2**

Post test surface damage inspection.

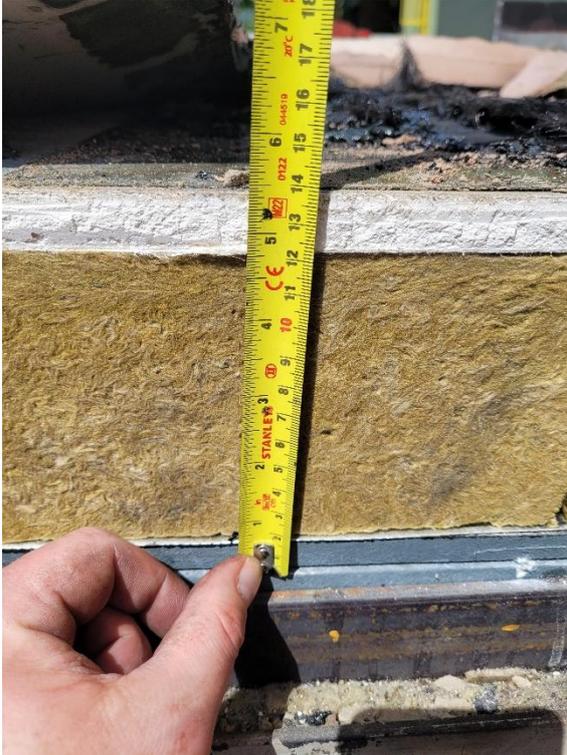
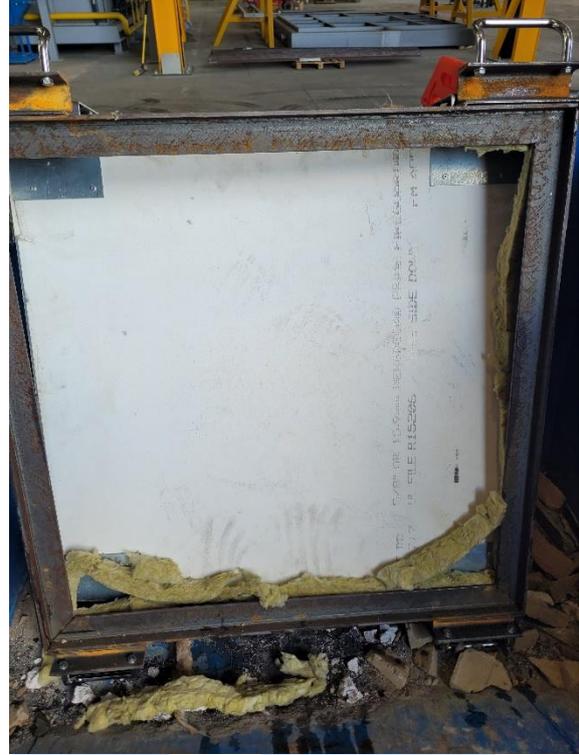
**9.7 Stage 2 S24040040-2**

Post test layer inspection.

Time (min:sec)	Observations on Sample No: S24040040-2
00:00	Test start
00:43	Smoke from specimen
05:00	Burning brand applied
05:14	Flaming on specimen surface starts
06:00	Removal of burning brand
07:20	Maximum height of flames from specimen
13:24	Flames from specimen starting to reduce
25:10	Flames from specimen cease
34:00	Peeling of specimen surface
Post test	At the end of 60 minute testing time, no penetration of the specimen was observed. The specimen sustained burning through to layer 2 but no further. As seen in the post test photos.

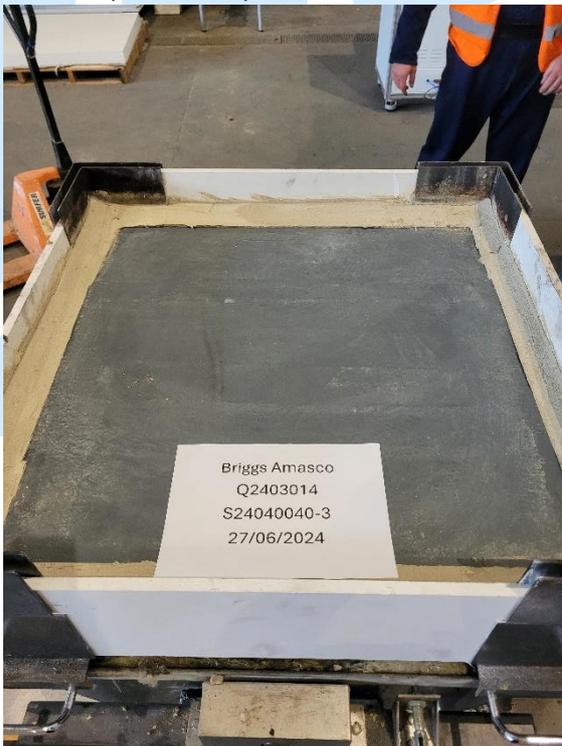
**9.8 Stage 2 S24040040-3**

Pretest picture of specimen.

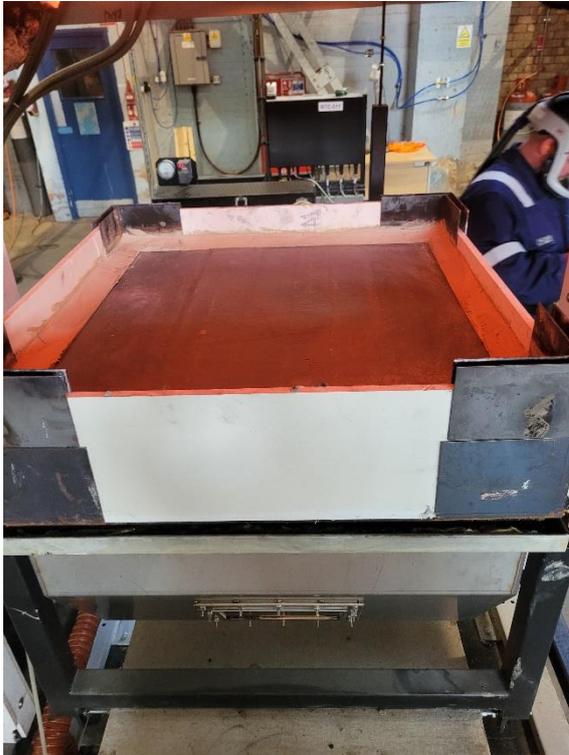
**9.9 Stage 2 S24040040 -3**

Before the application of the burning brand.

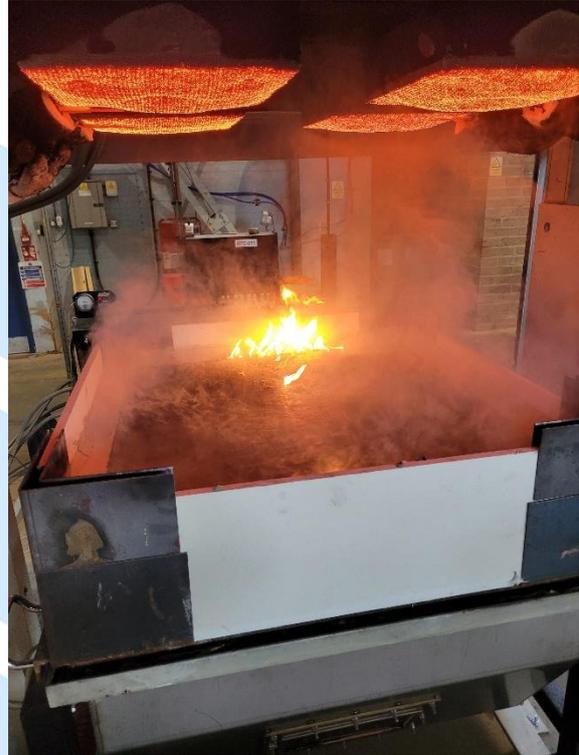
After the application of the burning brand.

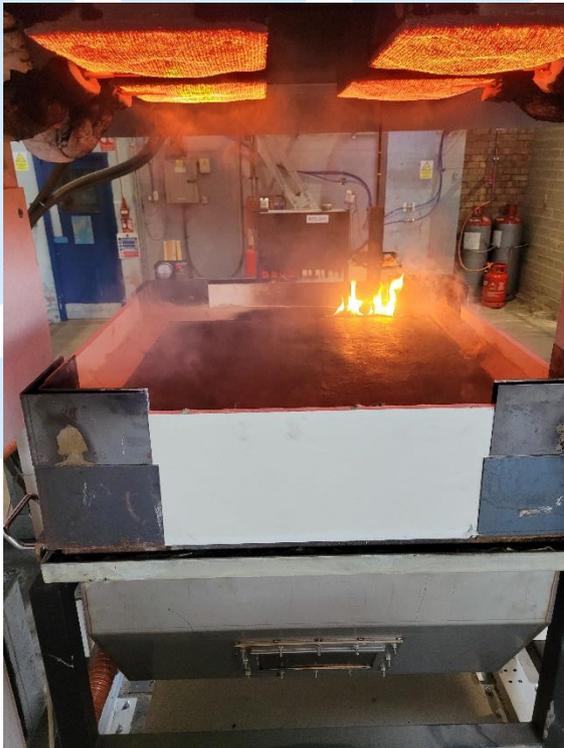
**9.10 Stage 2 S24040040-3**

Flames reducing mid test.

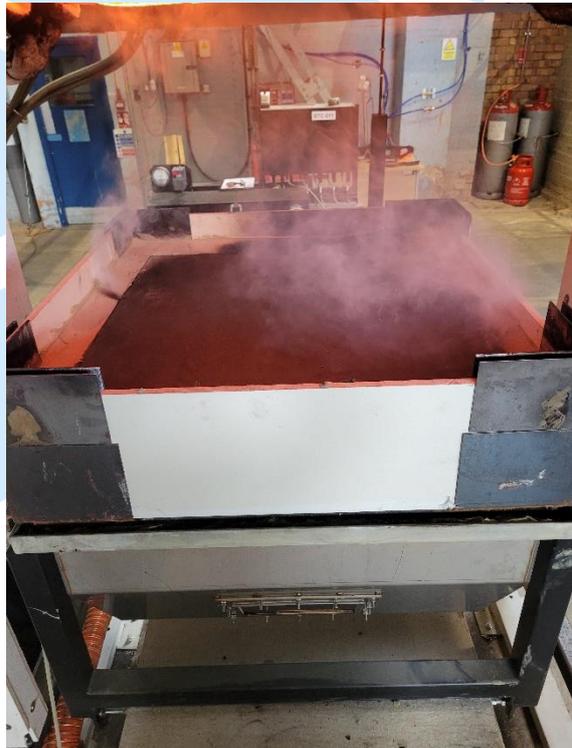
Flaming ceased on specimen surface.

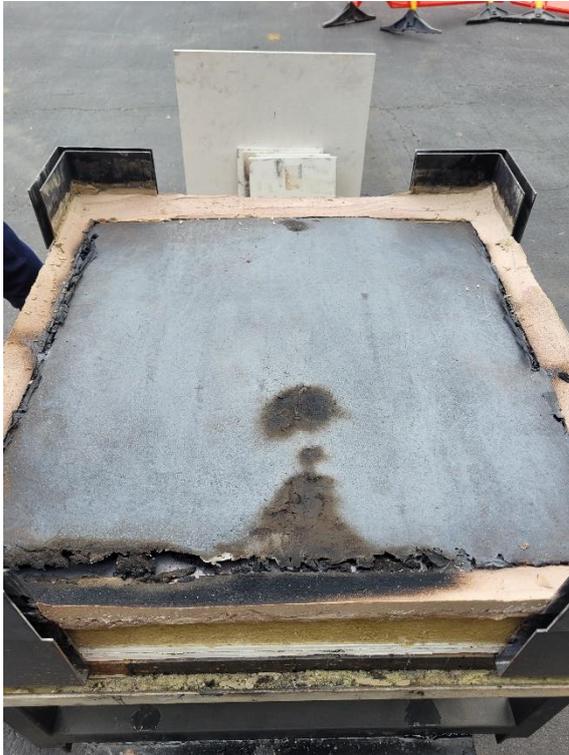
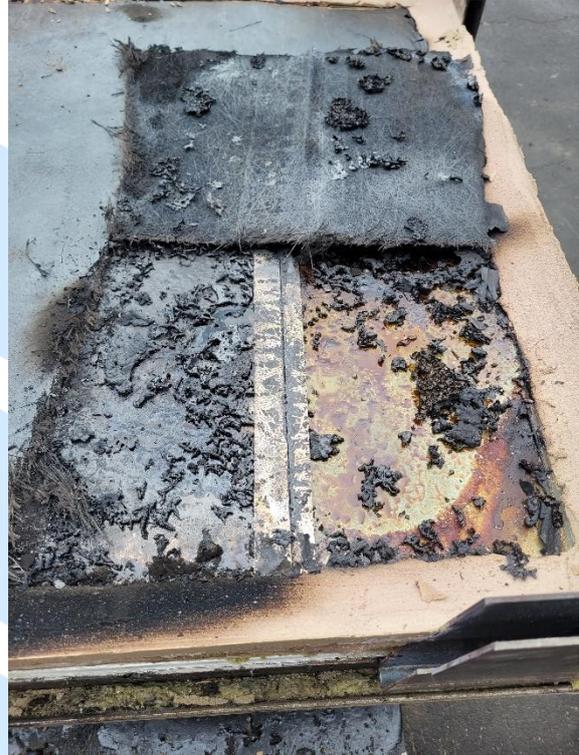
**9.11 Stage 2 S24040040-3**

Post test surface damage inspection.

Post surface damage inspection.

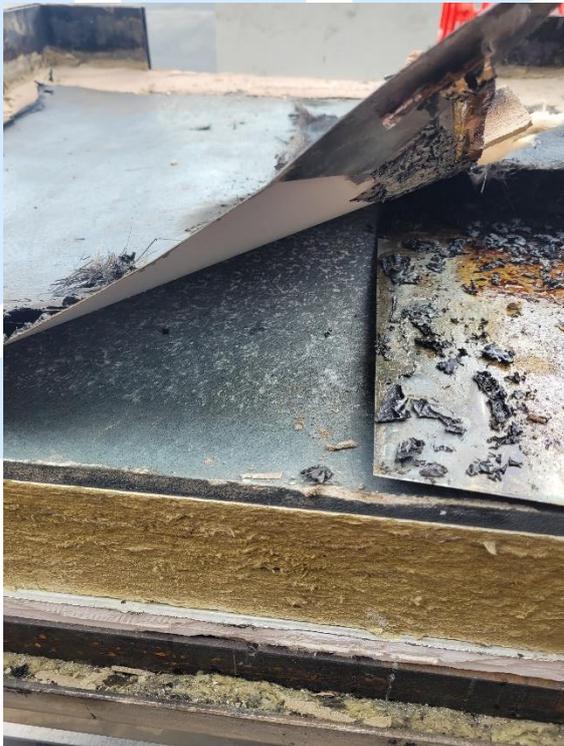
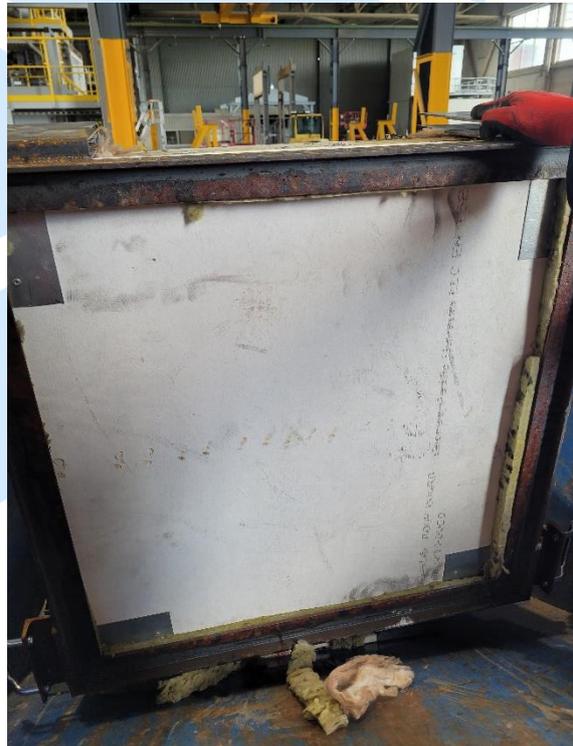
**9.12 Stage 2 S24040040-3**

Post test layer inspection.

<b>Time (min:sec)</b>	<b>Observations on Sample No: S24040040-3</b>
00:00	Test start
00:25	Smoke from specimen
05:00	Burning brand applied
05:06	Flaming on specimen surface starts
06:00	Removal of burning brand
06:40	Maximum height of flames from specimen
09:52	Flames from specimen starting to reduce
20:10	Flames from specimen cease
34:00	Peeling of specimen surface
Post test	At the end of 60 minute testing time, no penetration of the specimen was observed. The specimen sustained burning through to layer 2 but no further. As seen in the post test photos.

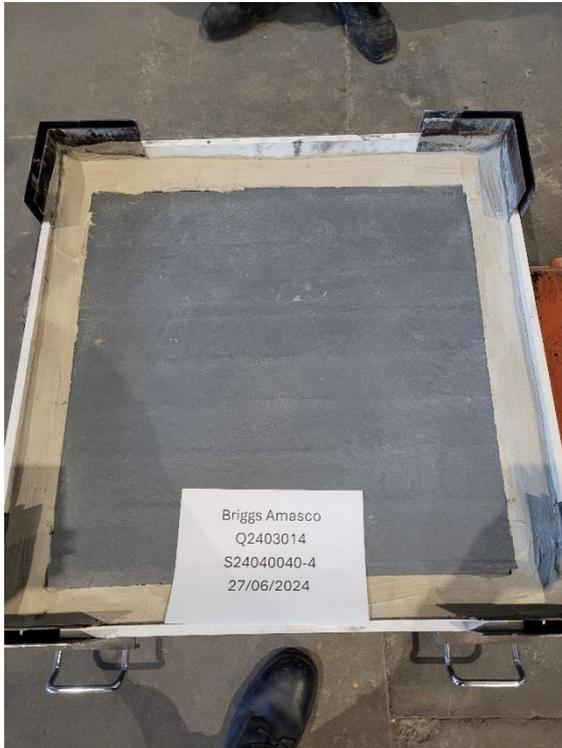
**9.13 Stage 2 S24040040-4**

Pretest picture of specimen.

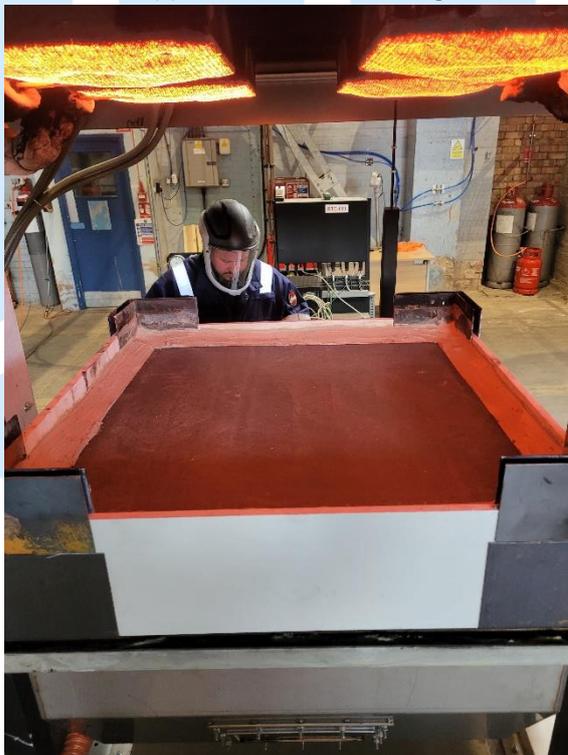
**9.14 Stage 2 S24040040 -4**

Before the application of the burning brand.

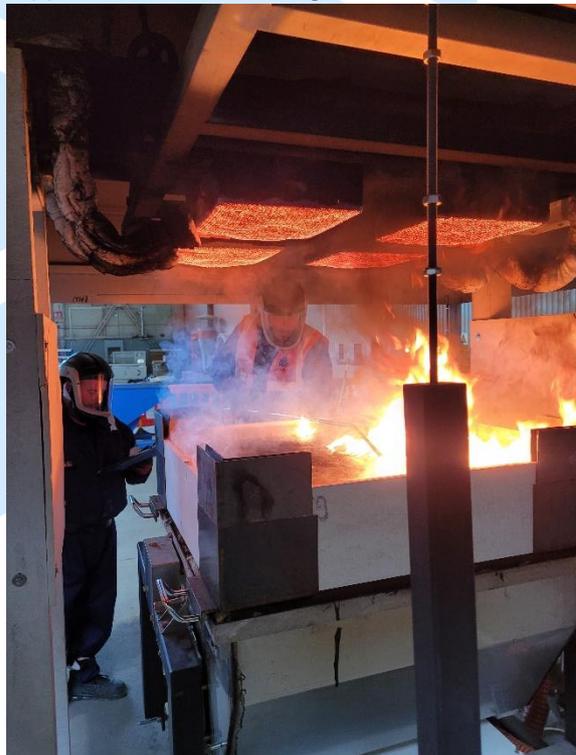
Application of the burning brand.

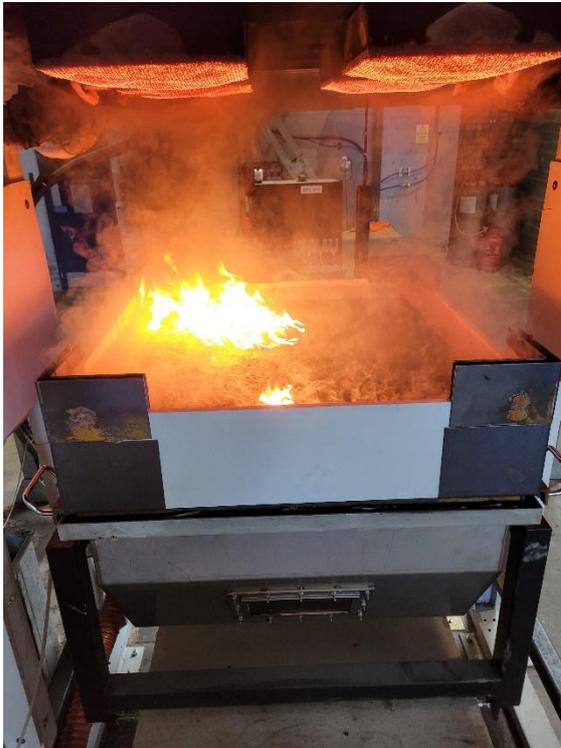
**9.15 Stage 2 S24040040-4**

Flames reducing mid test.

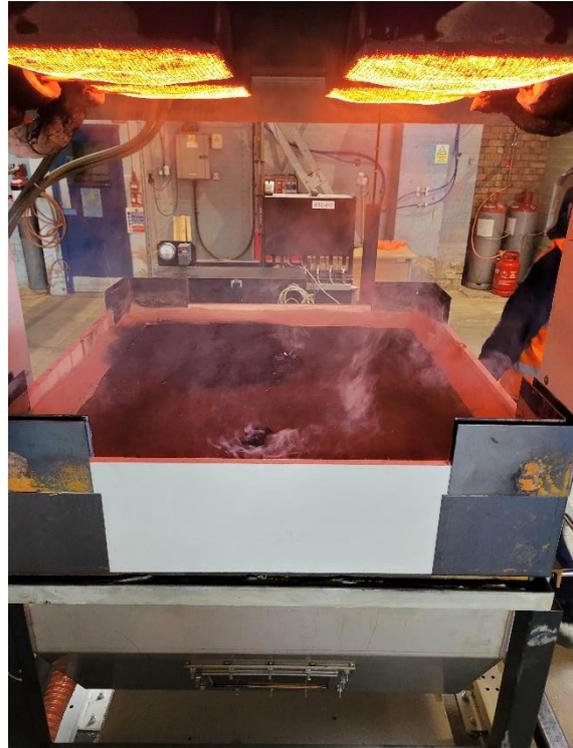
Flaming ceased on specimen surface

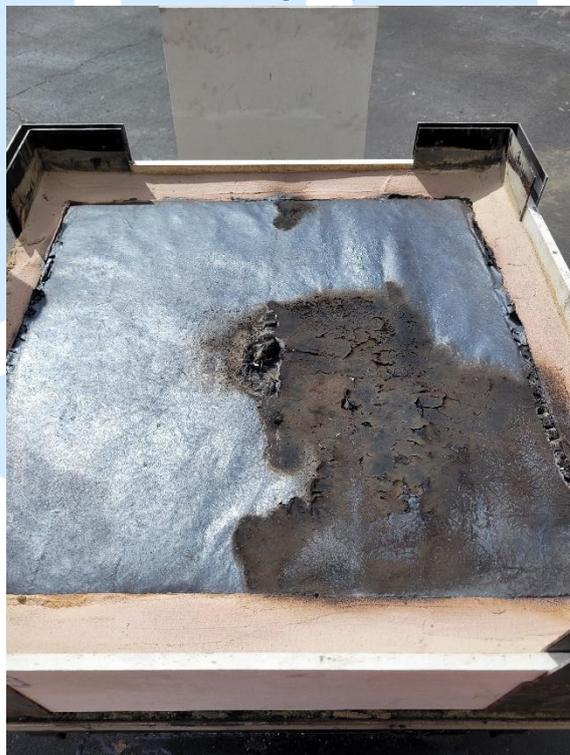
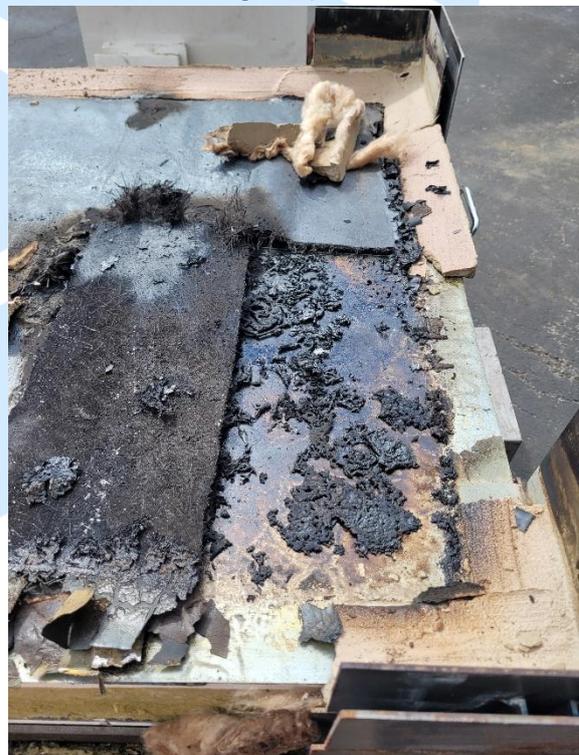
**9.16 Stage 2 S24040040 -4**

Post test surface damage inspection.

Post surface damage inspection.

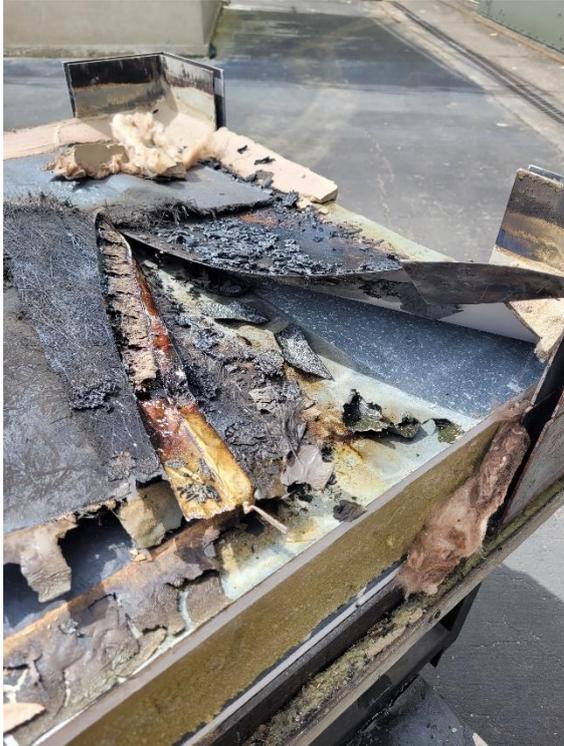
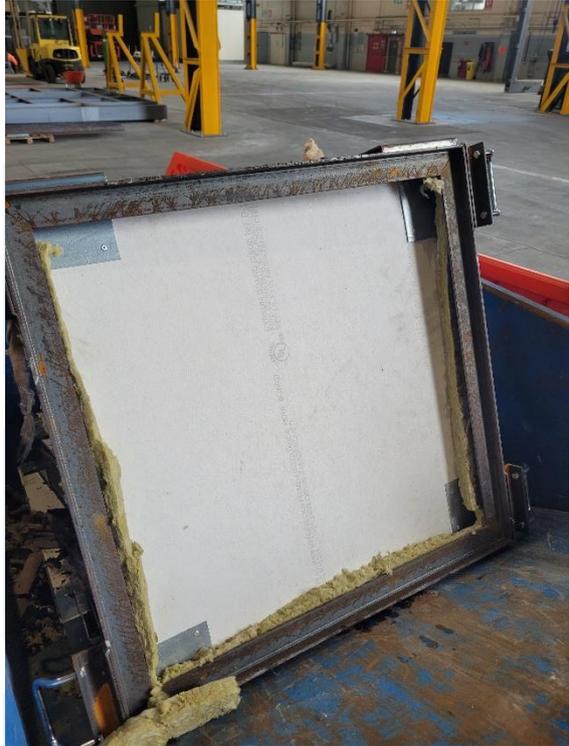
**9.17 Stage 2 S24040040-4**

Post test layer inspection.

<b>Time (min:sec)</b>	<b>Observations on Sample No: S24040040-4</b>
00:00	Test start
00:28	Smoke from specimen
05:00	Burning brand applied
05:03	Flaming on specimen surface starts
05:24	Peeling of specimen surface
06:00	Removal of burning brand
06:33	Maximum height of flames from specimen
08:30	Flames from specimen starting to reduce
14:24	Flames from specimen cease
Post test	At the end of 60 minute testing time, no penetration of the specimen was observed. The specimen sustained burning through to layer 2 but no further. As seen in the post test photos.
