Hangar One
Leeds East Airport
Church Fenton
Tadcaster
North Yorkshire
LS24 9SE

Aperture Weathering System

The test was carried out in accordance with;
DD CEN/TS 1187:2012 – Test 4
Test Methods for External Fire Exposure to Roofs

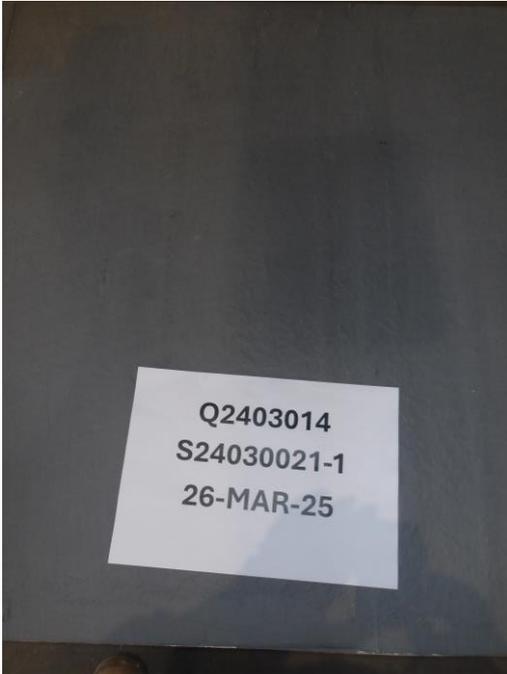
Pre-Test Specimen Picture

Stage 1 – S24030021-1

Sample Number:	S24030021-1
Lab Temperature [°C]:	18.5°C
Duration of Flaming [min:sec]:	00:00
Extent of Flame Spread [mm]:	60mm
Penetration Occurred:	No

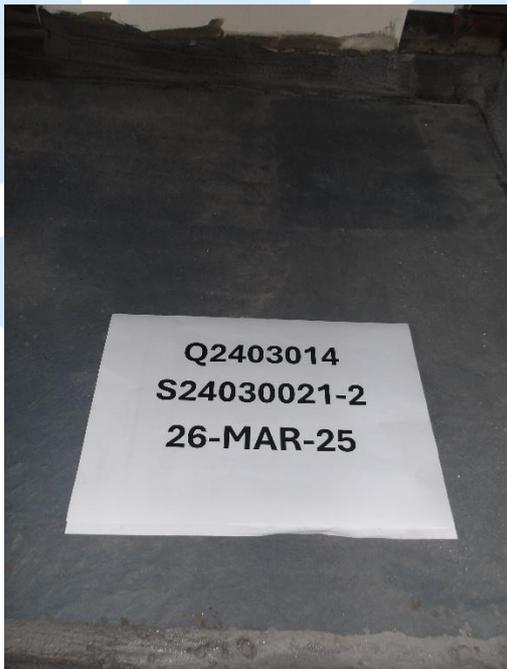
Pre-Test Specimen Picture

Stage 2 – S24030021-2

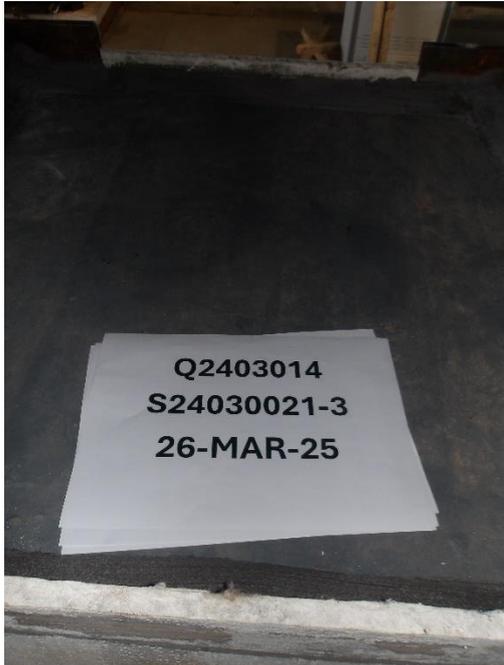
Pre-Test Specimen Picture

Stage 2 – S24030021-3

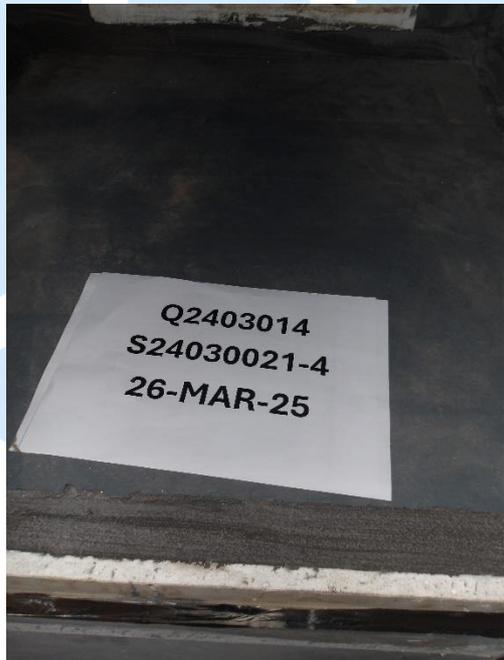
Pre-Test Specimen Picture

Stage 2 – S24030021-4
